Manhole Inspection Summary

Manhole # S150O1030MH

Insp Date: **11/30/06 1:07 PM**

Location Address: **2600 WOODLAND AVE**

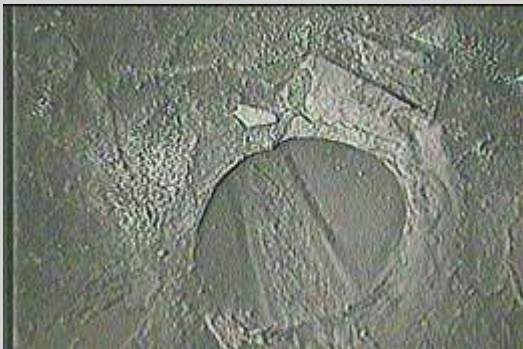
8 in. Circular Gravity Sewer Pipe In @ 3 O'Clock

Invert Depth: **13.05** (ft.) Flow Characteristics: **Fast**

Infiltration: **None** Pipe Seal Cond: **Unknown**

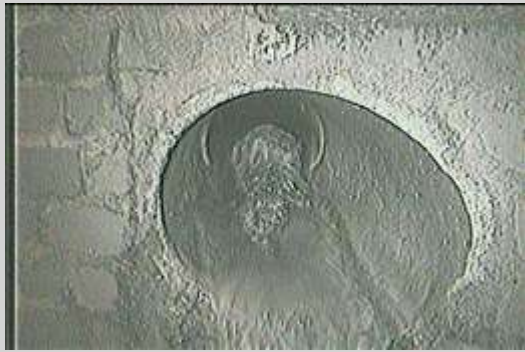
10 in. Circular Gravity Sewer

Invert Depth: **10.73** (ft.) Flow Characteristics: **Turbulent**

Infiltration: **None** Pipe Seal Cond: **Unknown**

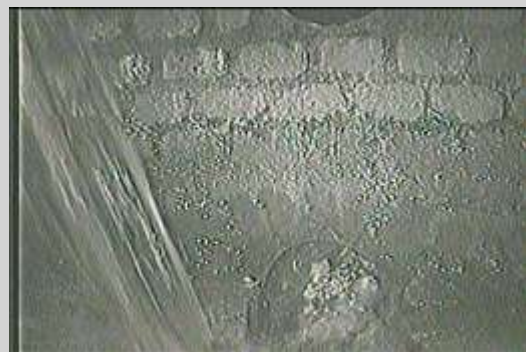
Drop In @ 8 O'Clock

Infiltration: **None** Pipe Seal Cond: **Cracked**

Drop: **Outside** Rod and Bar
Angled: **Yes** Reading: **12.48** (ft.)
Inv Depth: **13.48** (ft.)
Drop Condition: **Open**
